Ynyslas Storm & Flooding

3-6th January 2014

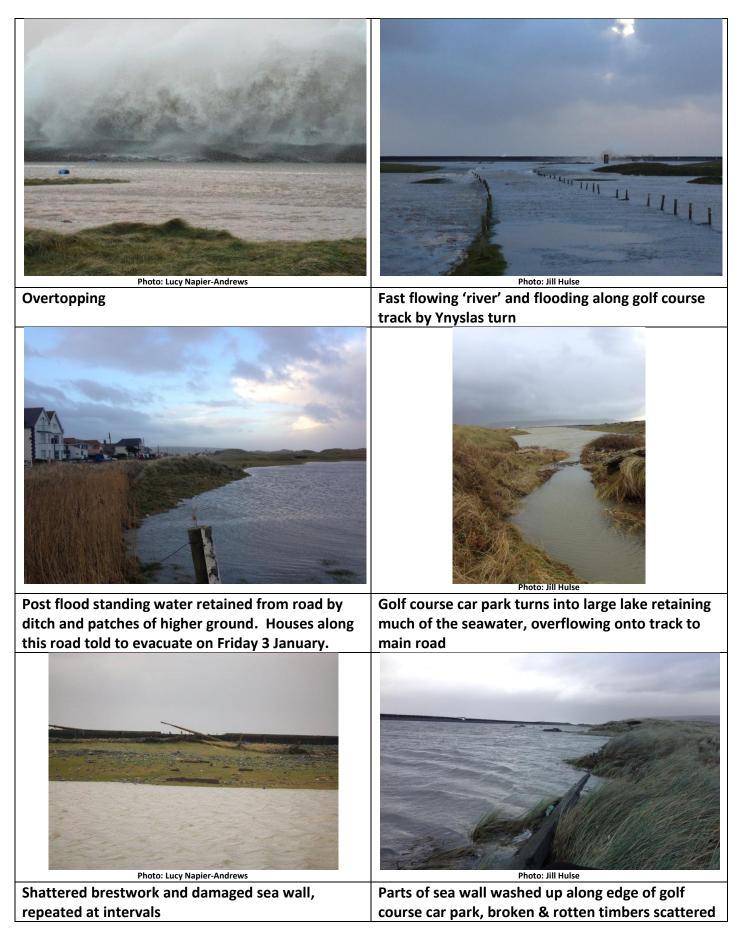
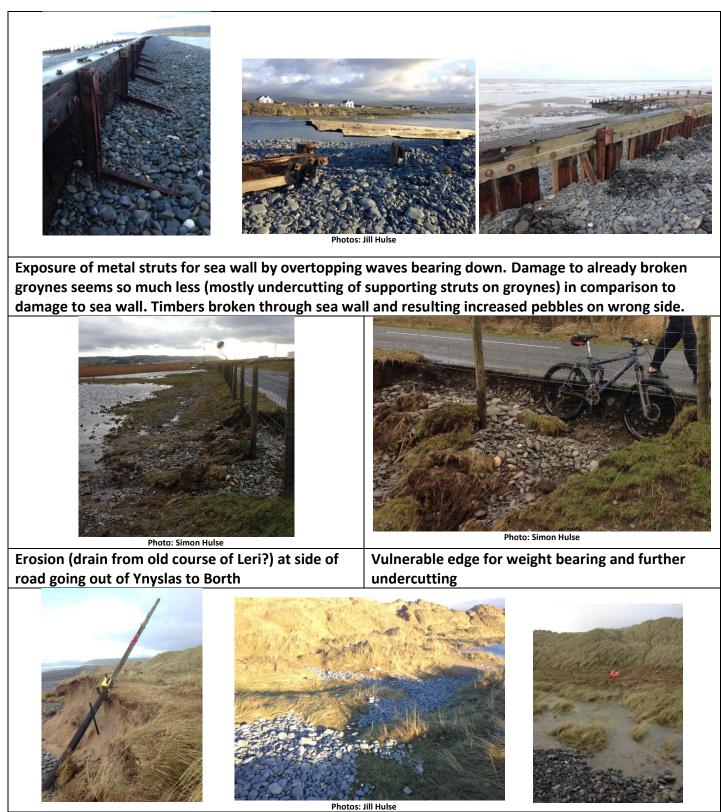
Emergency phone pole uprooted and cable severed. This has since been washed further down and inland into dunes. Stones running in like tributaries into dunes. Emergency life ring & structure uprooted and displaced.

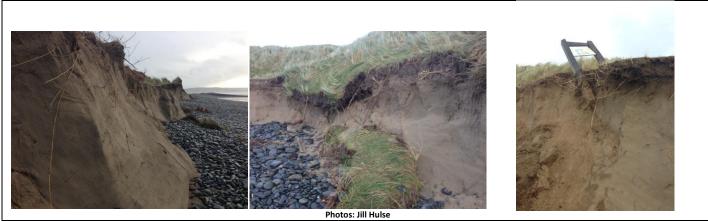
Erosion of approx 6-8' sand dune, collapse of undermined dunes, Informal dune path eroded away leaving NNR post exposed

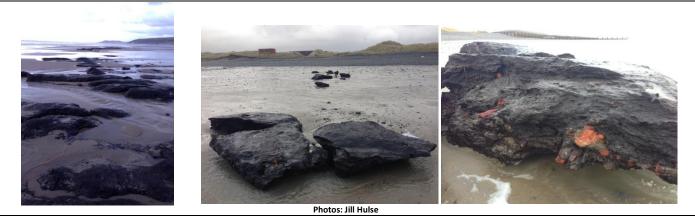
Exposure of fossilised forest more than usual, slabs eroded out, evident fresh tearing of ancient roots
